Upper Salmon River Subbasin Assessment and TMDL

2016 Addendum and Five-Year Review

Hydrologic Unit Code 17060201

**State of Idaho
Department of Environmental Quality**

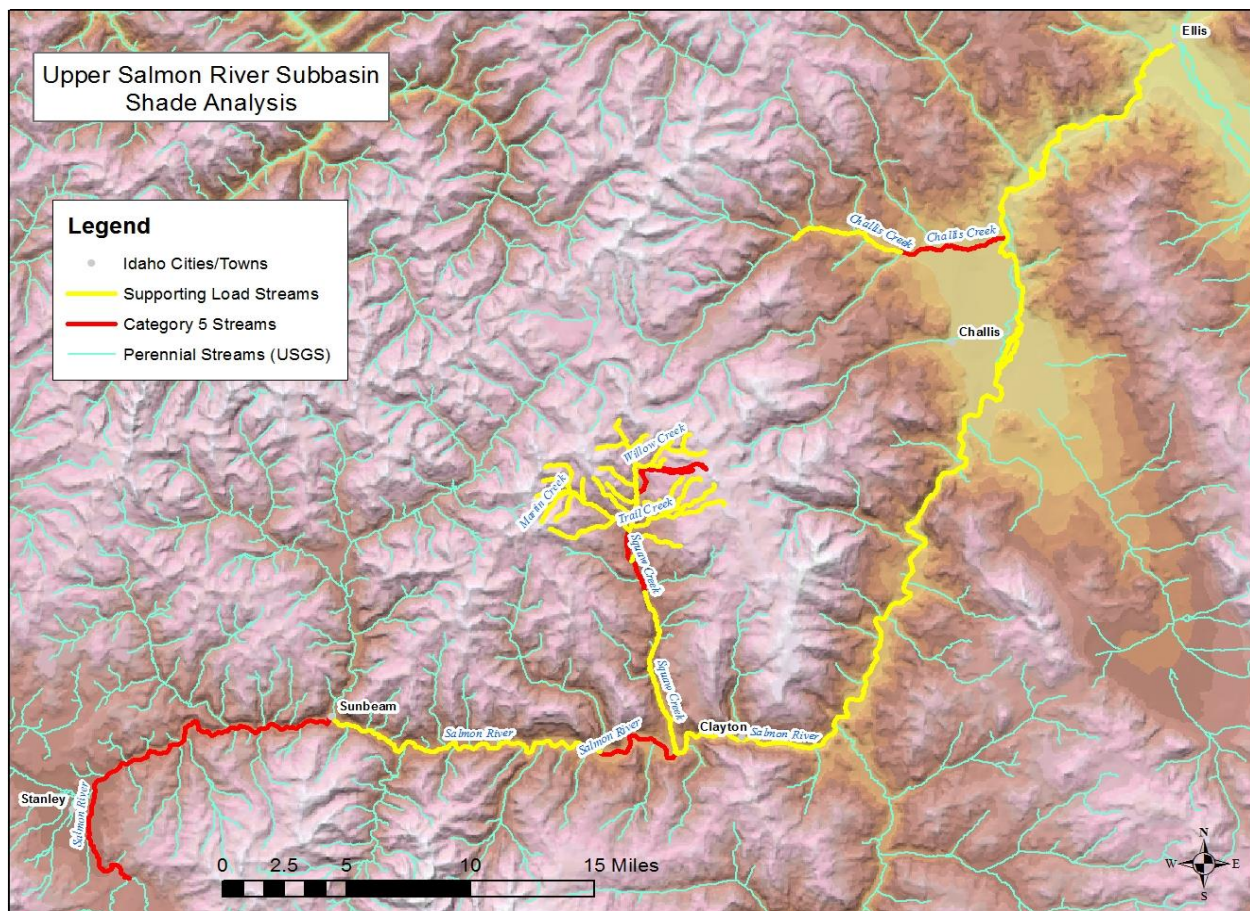
Figure B. Upper Salmon River subbasin shade analysis based on the 2012 Integrated Report.

Most AUs are in reasonably good condition with respect to shade and thermal loads. The majority of AUs have average lack of shade values at or under 10% and necessary load reductions less than 20%.

All streams require some rehabilitation to achieve shade targets. Target shade levels for individual stream segments should be the goal managers strive for with future implementation plans. Managers should focus on the largest differences between existing and target shade as locations to prioritize implementation efforts. Load analysis tables and figures showing lack of shade can be used to prioritize implementation efforts in key areas.

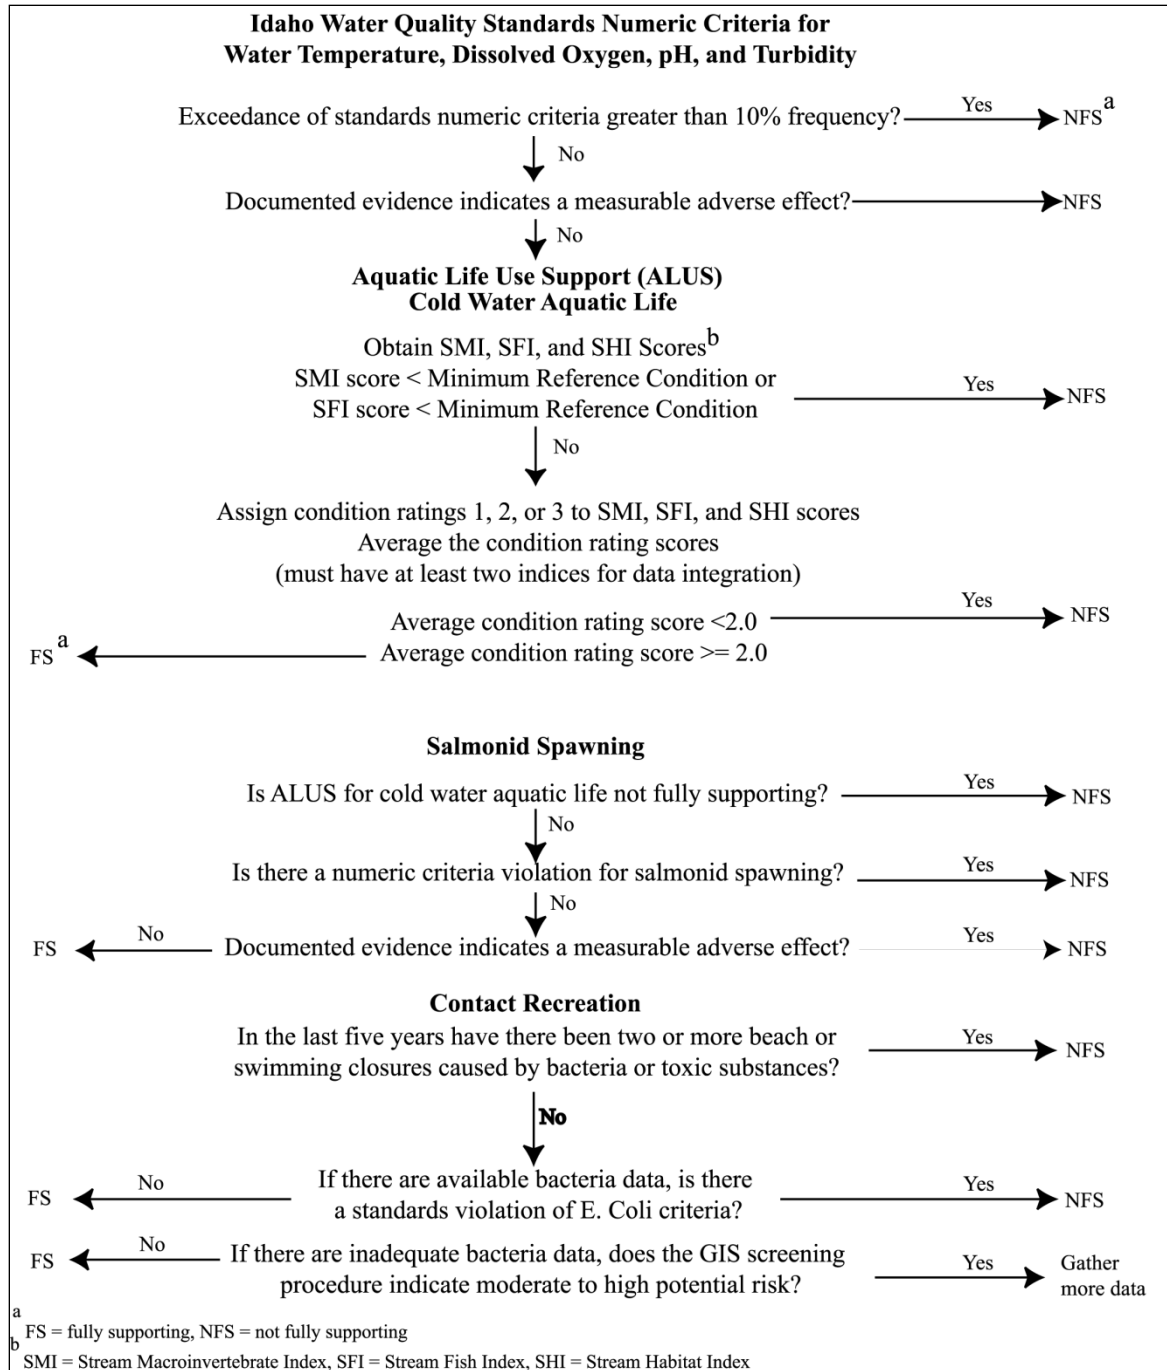
Figure 3. Steps and criteria for determining support status of beneficial uses in wadeable streams (Grafe et al. 2002).

DEQ's procedure to determine whether a water body fully supports designated and existing beneficial uses is outlined in IDAPA 58.01.02.050.02. The procedure relies heavily on biological parameters and is presented in detail in the *Water Body Assessment Guidance* (Grafe et al. 2002). This guidance requires DEQ to use the most complete data available to make beneficial use support status determinations (Figure 3).

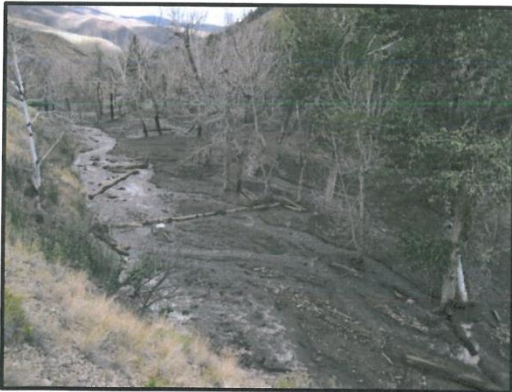
Challis Creek was pushed to the north side of the valley, and the channel was routed onto about 550 feet of the Challis Creek Road.

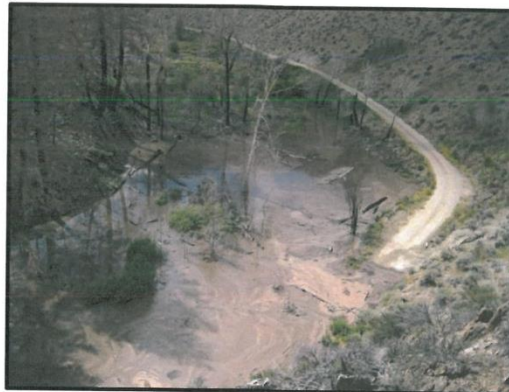
Debris from the blowout caused considerable aggradation over the entire valley width (150-300 feet) along a distance of about 1000 feet. The road was along the left side of the valley.

The debris fan dammed Challis Creek, inundating about 200 feet of road and several hundred feet of channel/floodplain.

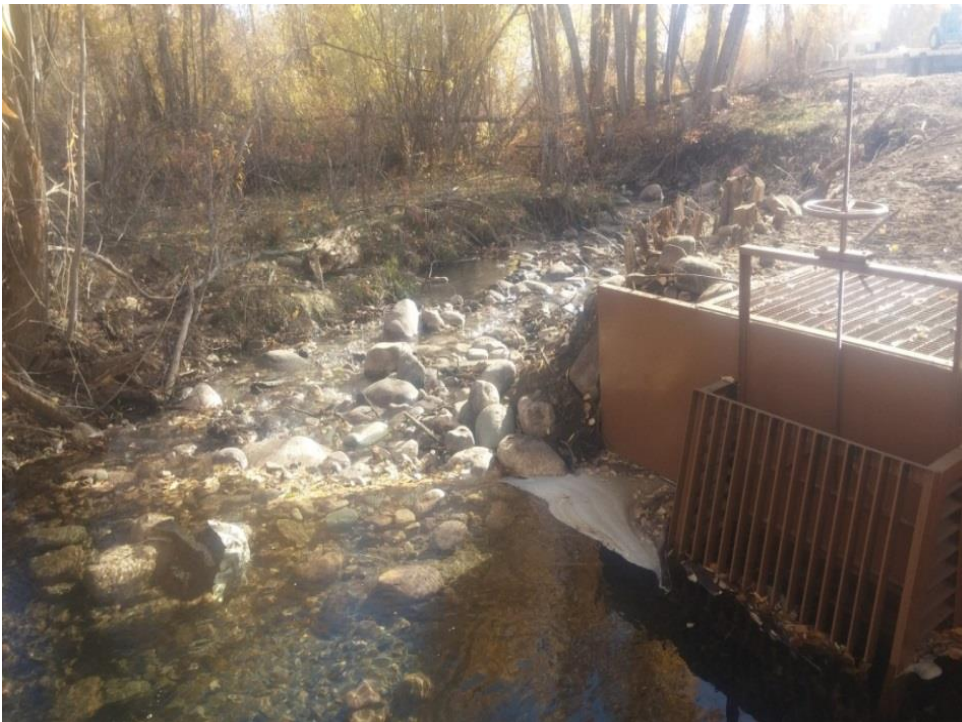
Figure 14. Improved Garden Creek diversion structure and rehabilitated stream substrate.

Garden Creek has had several structural improvements since the 2003 TMDL. In addition to the Gini Canal diversion improvement (discussed in Appendix B and USBR 2007), other diversion structure improvements have been made, such as the improvement to the Challis water supply diversion and the Garden Creek irrigation diversion. Older structures were removed and replaced with fish-friendly diversion structures and improved berm and stream channels (Figure 14). The City of Challis is also working toward shifting back to well water, rather than surface water from Garden Creek, as its drinking water source (K. Bragg, Custer Soil and Water Conservation District, personal communication, November 2014).

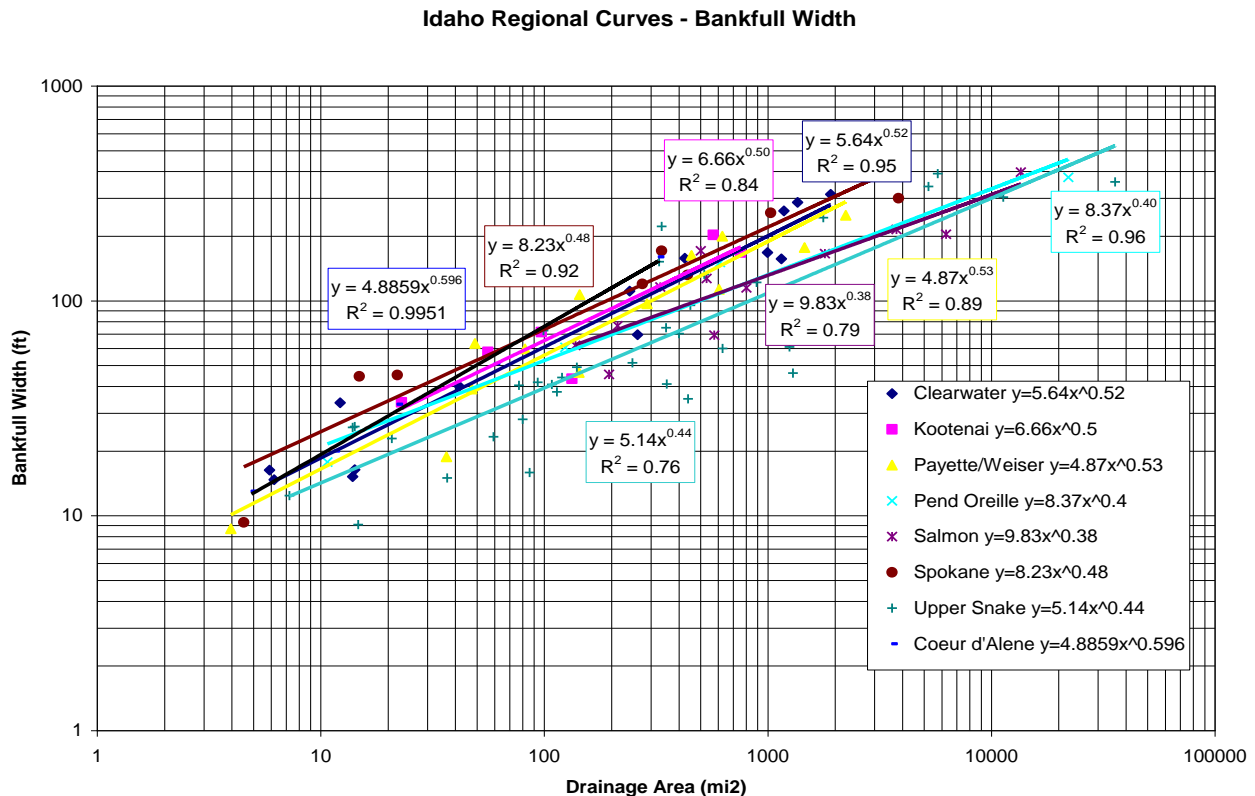
Figure 17. Bankfull width as a function of drainage area.

For each stream evaluated in the load analysis, natural bankfull width was estimated based on the drainage area of the Salmon Basin curve from Figure 17. For streams in the analysis, existing width data should also be evaluated and compared to these curve estimates if such data are available. However, for the Challis Creek and Squaw Creek watersheds, only a few BURP sites exist, and bankfull width data from those sites represent only spot data (e.g., only three (3) measured widths in a reach just several hundred meters long) that are not always representative of the stream as a whole. We chose to use the Salmon Basin estimates of channel width for the majority of small streams in the upper Squaw Creek watershed. No BURP data exist for this region; thus we chose to use the basin of origin for these higher elevation streams.

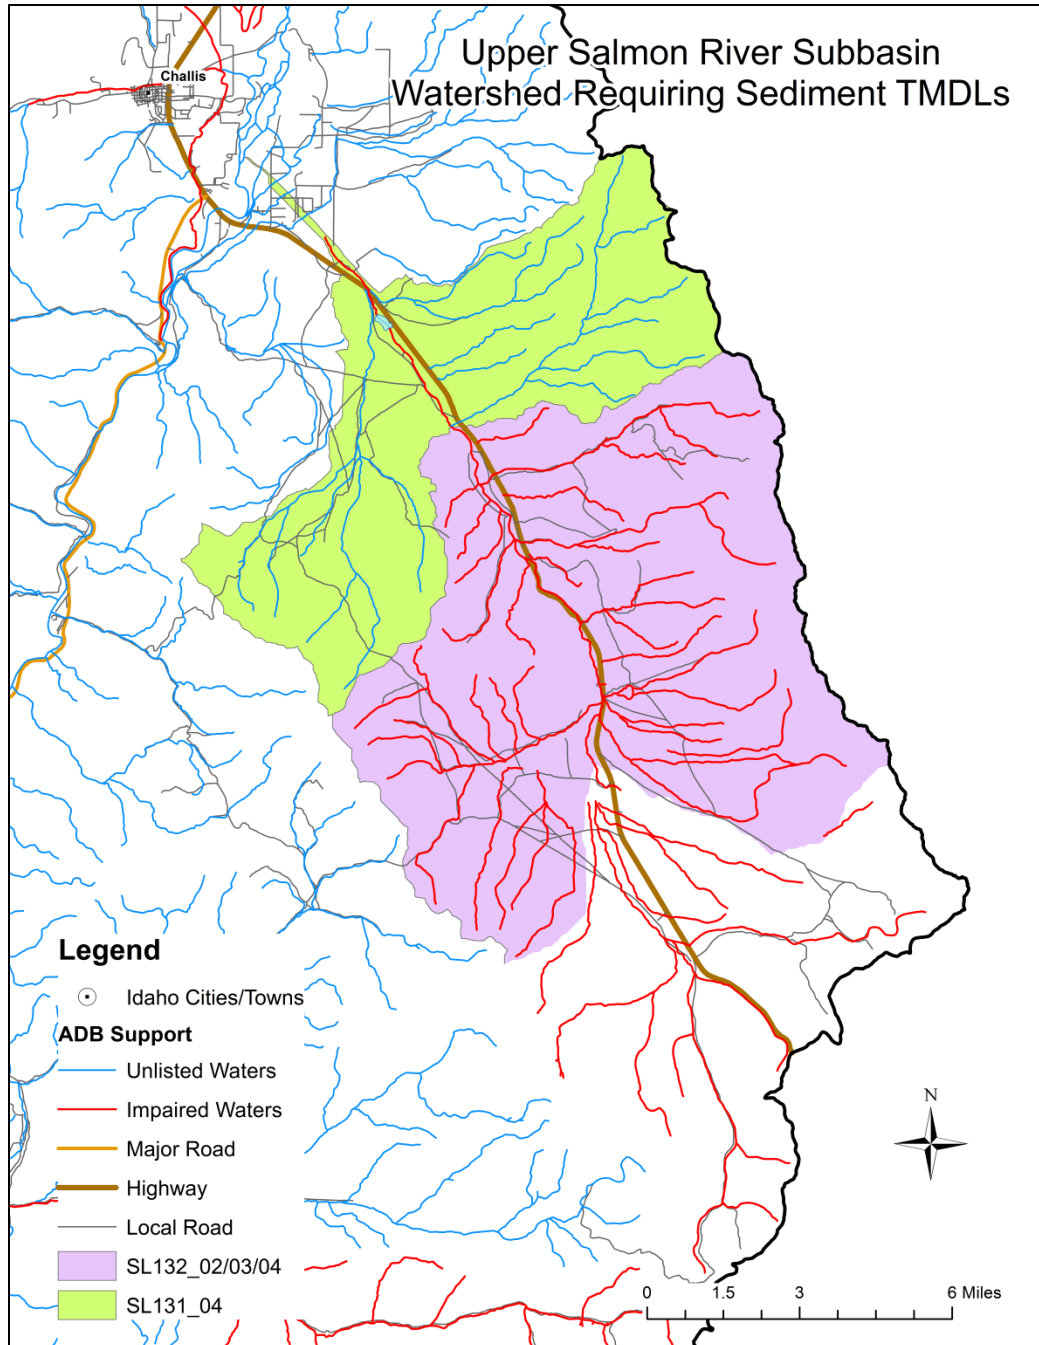
Figure 20. Assessment unit segments and subwatersheds requiring sediment reductions in the Upper Salmon River subbasin.

Four AUs require load reductions that are being developed in this TMDL (Table 25; Figure 20). There is an automatic assumption that measured/observed streambank erosion was based on a single year of erosion (tons/year). This assumption most likely overstates the loads as the combination of water withdrawals and naturally intermittent reaches diminishes the stream power, and observed erosion/sediment build-up is most likely occurring over multiple years. This assumption is deemed appropriate as the streams do transport sediment when water is flowing and at rates that cause impairments to the beneficial uses; any additional mass of sediment is considered as additive to the overall margin of safety. According to the 2003 TMDL, the perennial portion of Warm Spring Creek flows approximately one hundred (100) yards in its natural channel before it is diverted in its entirety into a constructed channel for agriculture and hydroelectric purposes, leaving no water in the original natural stream course. The lowest AU (ID17060201SL131_04) is specific to the Warm Spring Creek main stem, but the contributing area is highlighted for discharge estimation purposes (Figure 20).

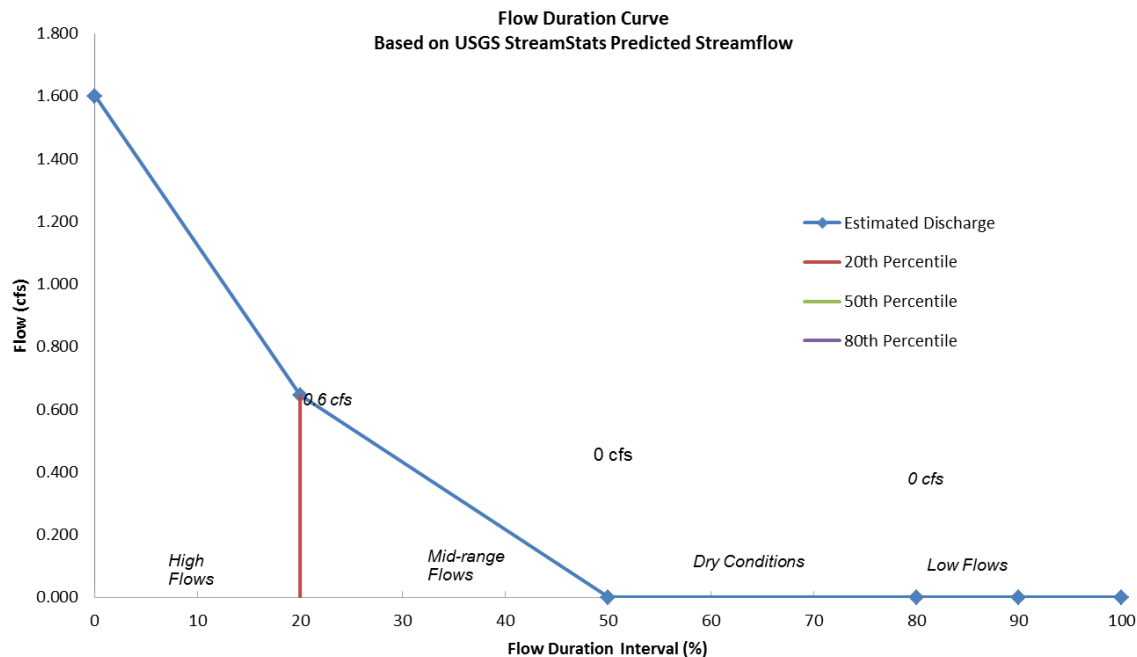
Figure 22. Flow duration curve for the ungaged stream segment in Warm Spring Creek (ID17060201SL132_02/03/04).

High flow period lasts 73 days (20% of year) where 79% of the annual flow occurs (based on ratio of midpoints or $1.1/1.1+0.3$). Mid-range flow lasts 110 days (30% of year) where 21% of the annual flow occurs (based on $0.3/1.1+0.3$). Prorating the load allocation over these time periods and flow volumes results in 30.8 tons per day during the high flow and 5.4 tons per day during the mid-range flow, however, it is recognized that the wasteload allocation will exist during the low flow period (see LA in Table 26).

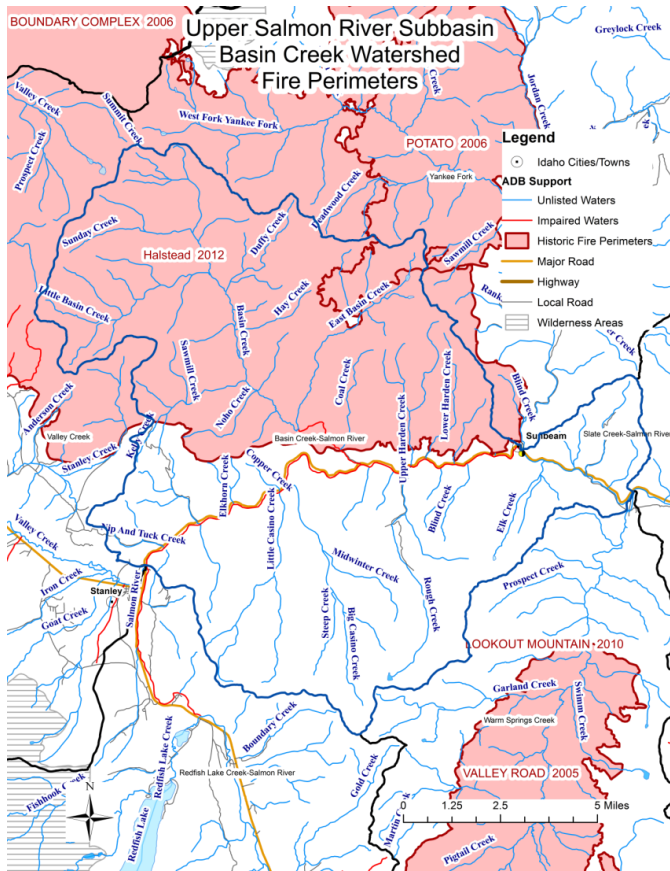
Halstead Fire perimeter overlay of Basin Creek

Recommendation: This AU should remain in Category 5 for sedimentation/siltation as the Halstead fire has made any examination of the habitat illogical. It is recommended that in approximately 2018 this AU be monitored using BURP protocols (or equivalent) to confirm complete recovery and a full-assessment process.

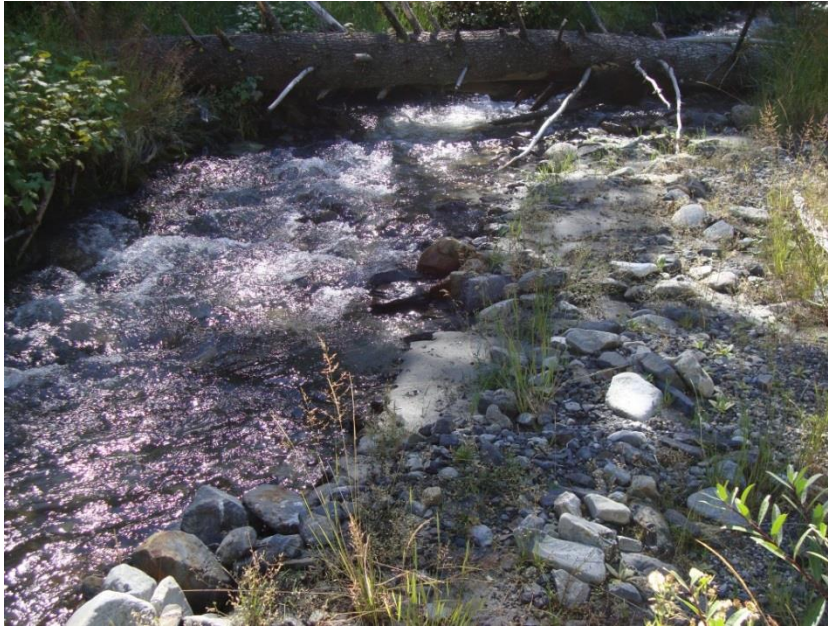
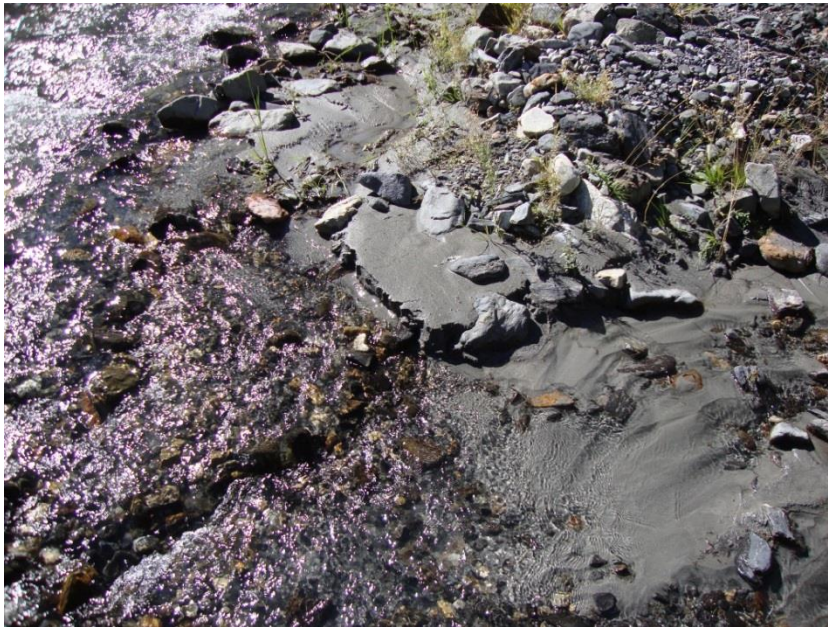
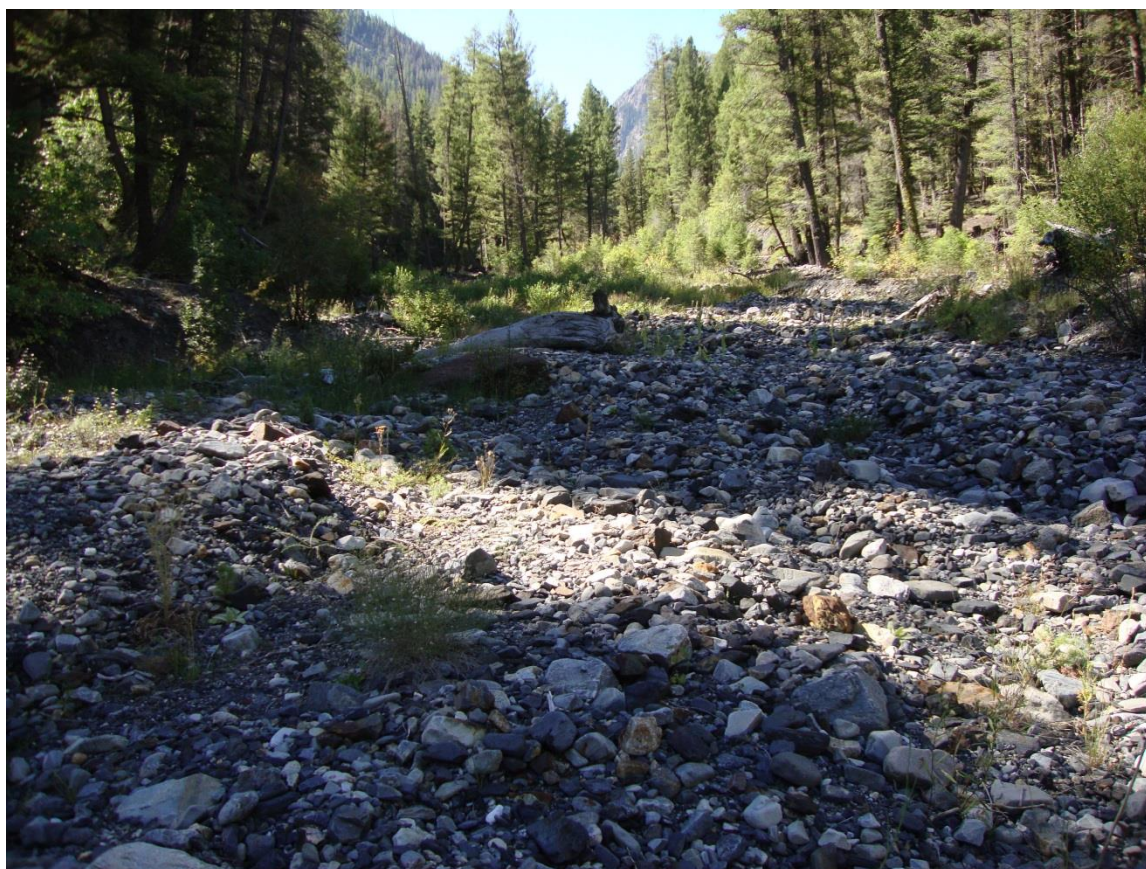
Slate Creek within microburst washout

Slate Creek within microburst washout, note lack of channel structure

Recommendation: Relisting in Category 4c, physical substrate habitat alterations, as the impairment is due to the 1998 microburst storm event. The upper AU was monitored to develop a baseline measure and should be followed by monitoring in 5–10 years to examine for recovery. Floodplain/riparian habitat is required to develop, along with a defined thalweg, before the sediment sources are completely removed.

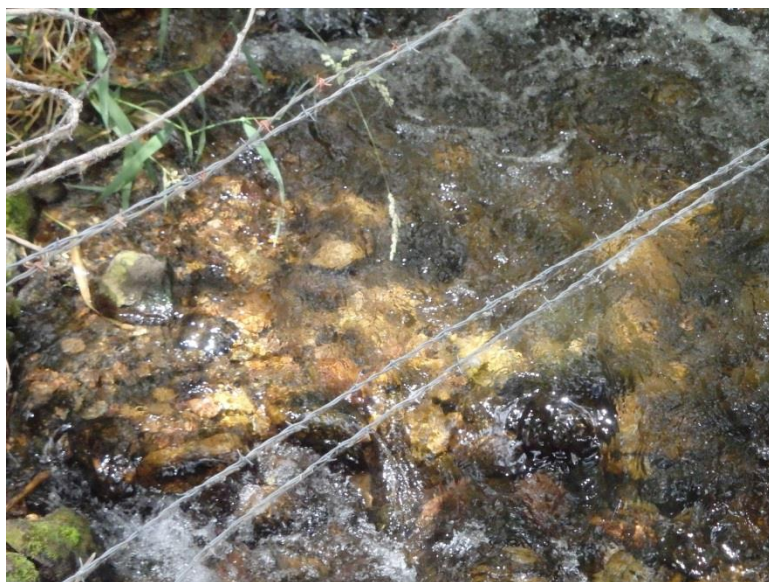
Note moss growth (not nuisance growth) on rocks during July 22, 2014, site visit.

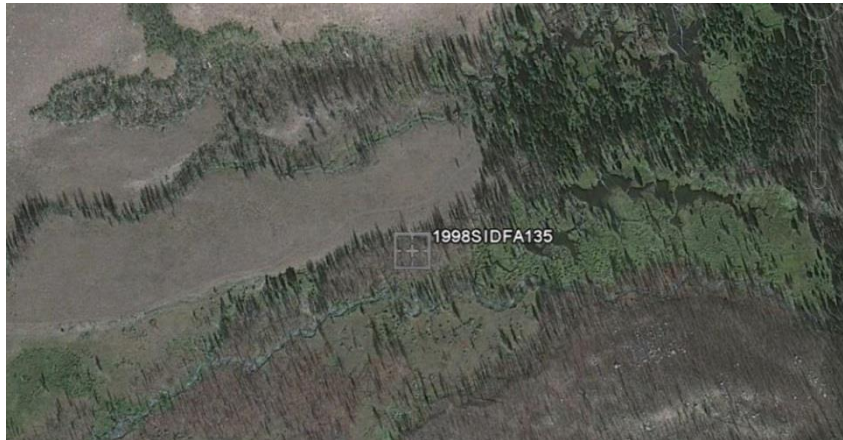
Location of BURP monitoring within Champion Creek, note beaver dams upstream of the site

Recommendation: Based on an examination of the aerial photos pre- and post-fire, several washouts appear to have occurred on the north-facing slopes; however, by 2013 there was increased vegetation stabilizing those slopes. Multiple canals remove water from this creek, so while Champion Creek currently has passing BURP scores, dry year water withdrawals could affect the biota (both fish and riparian vegetation) and may lead (and has led) to substandard scores. This creek should be delisted from Category 5 and moved to Category 2. Future assessments should account for potential indications of impairments due to the altered flow regime through the application of water rights.

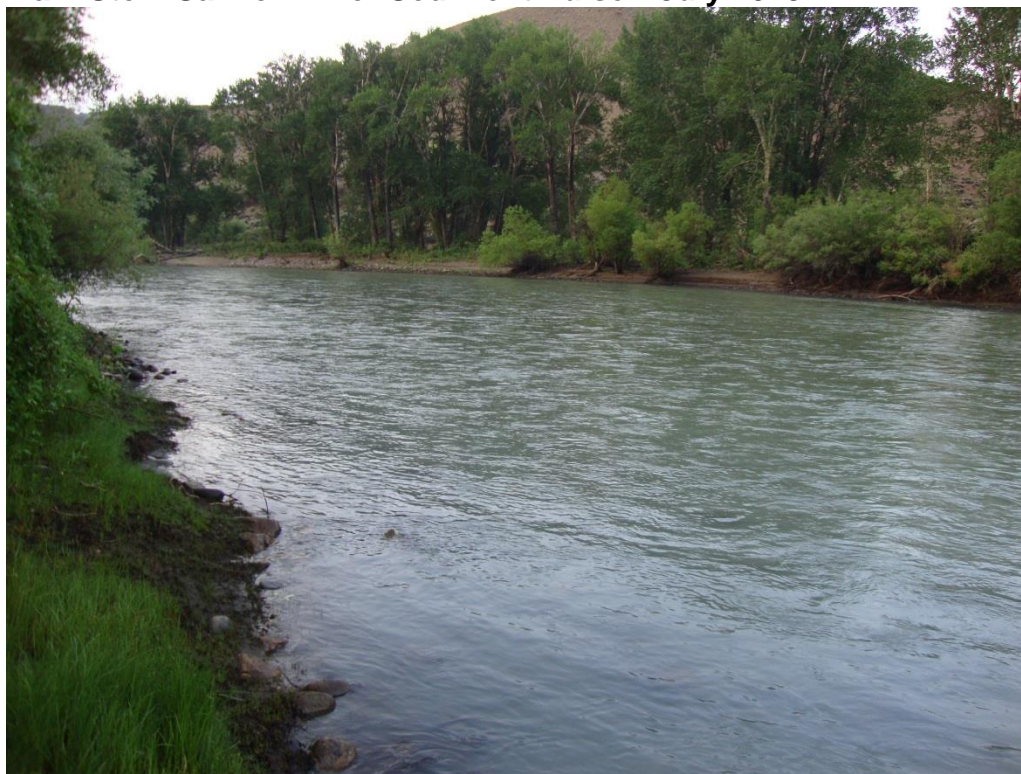
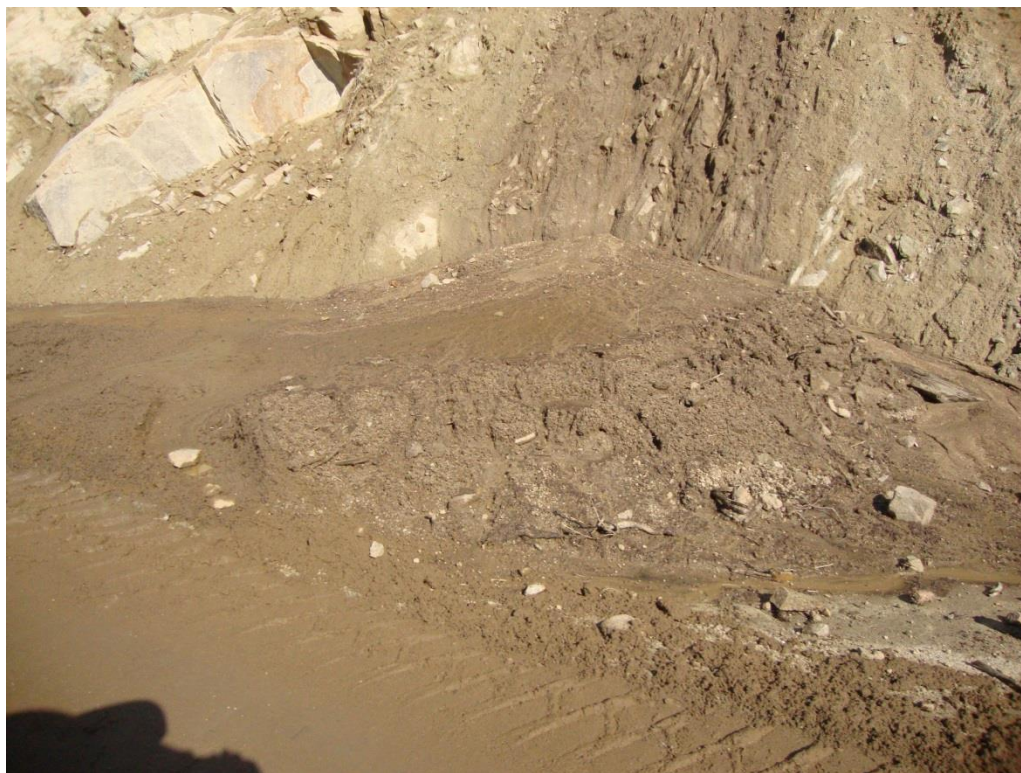
Road cut failure and mudslide, location currently under repair and improvement

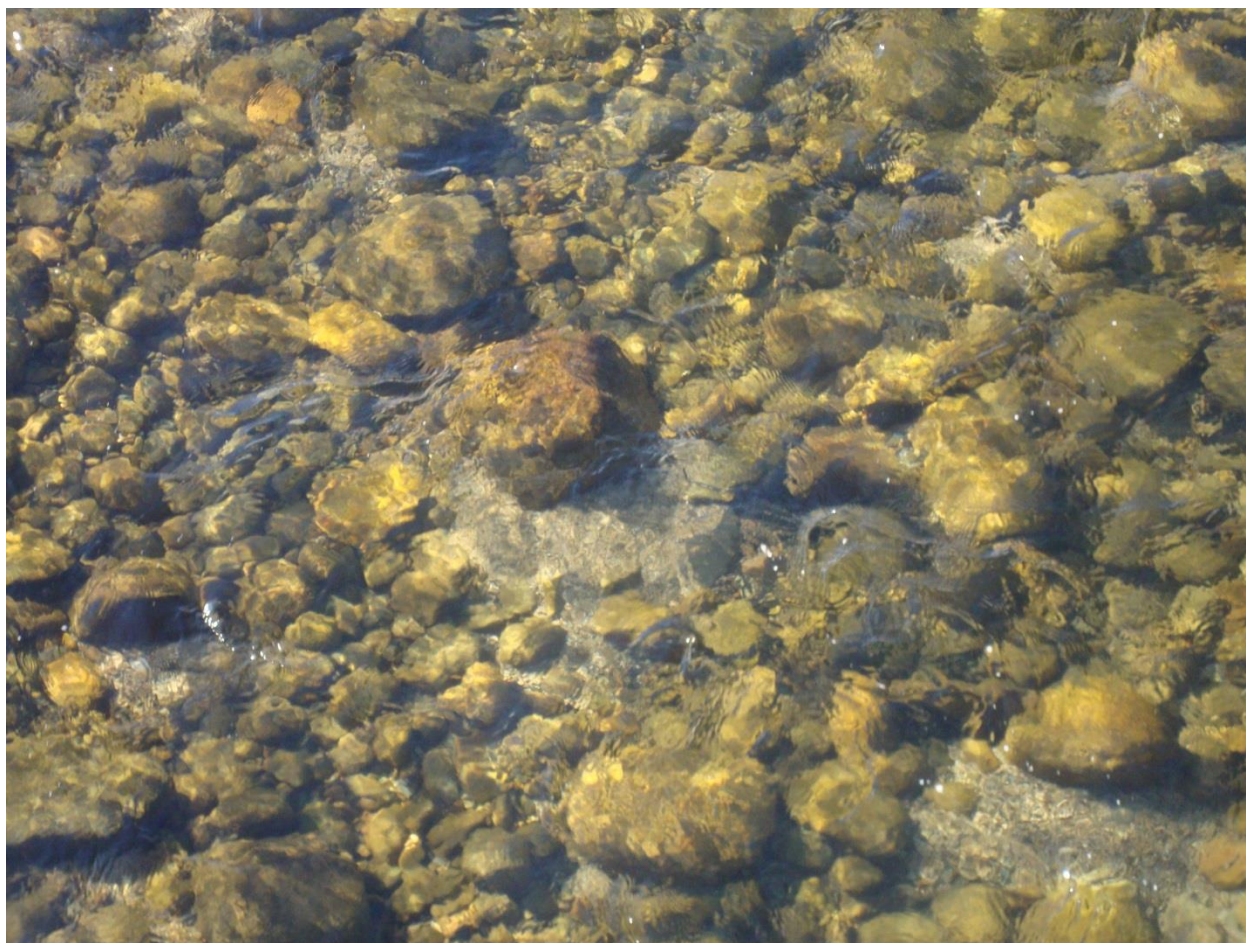
Isolated sand (fines) deposition in Salmon River

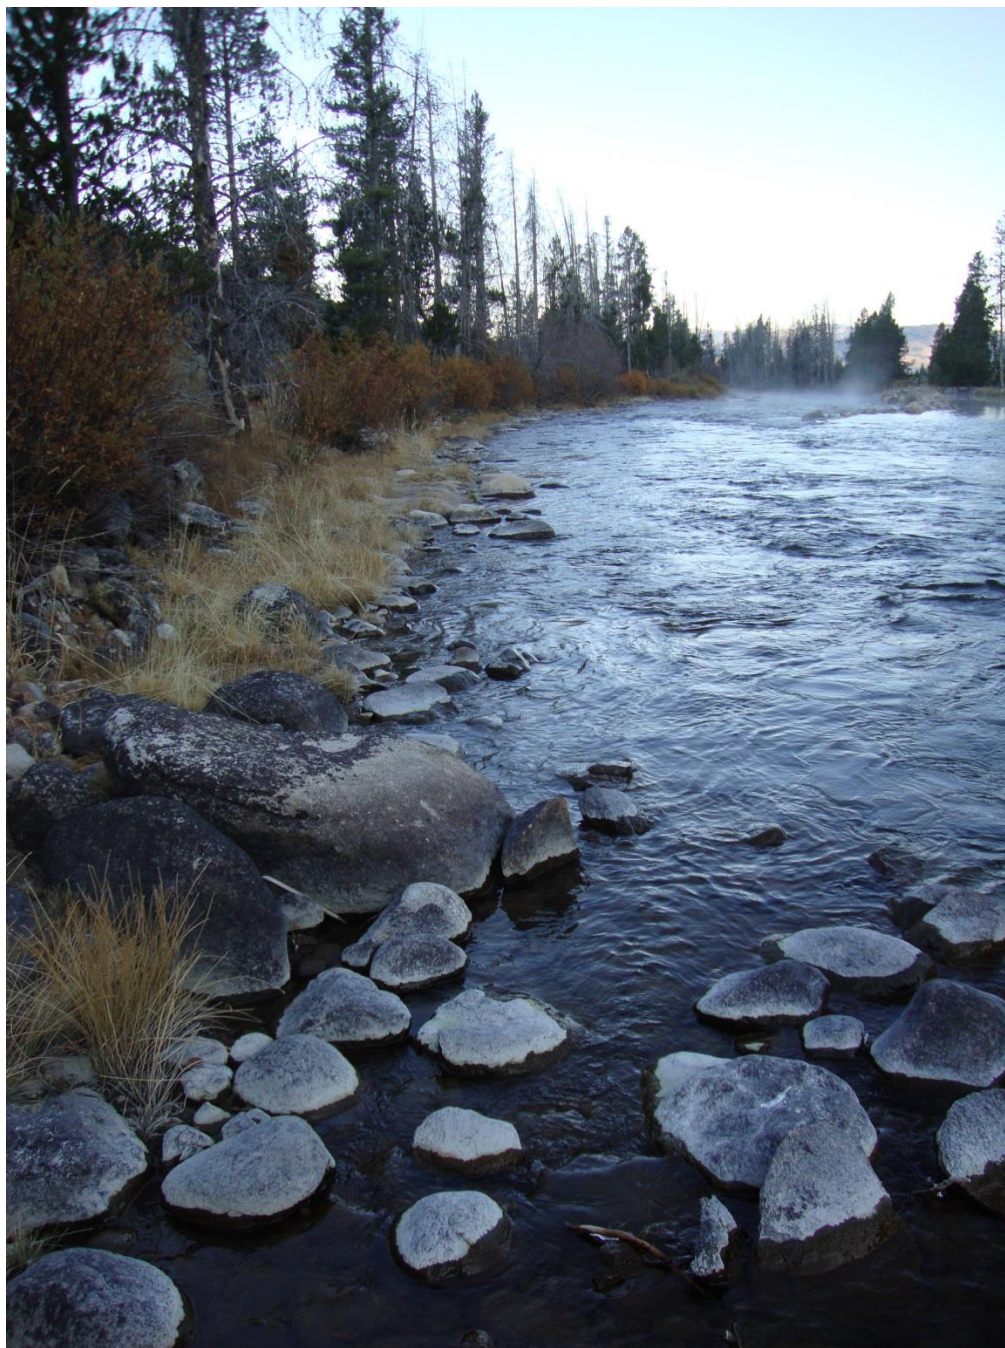
Cobbles and bank within Salmon River – Redfish Lake Creek to Valley Creek

Most of this AU has a channel that is geologically controlled by the bedrock. There is very little space for lateral erosion as the terraces are composed of cobbles and boulders, and the bedrock limits incision. Much of the AU is composed of granite, and erosion and sediment sources are typically composed of decomposed granite and are not composed of fine particles as the soils are only minimally developed through much of this area. There are no identifiable impairments due to sediment. The AU is impaired for temperature.

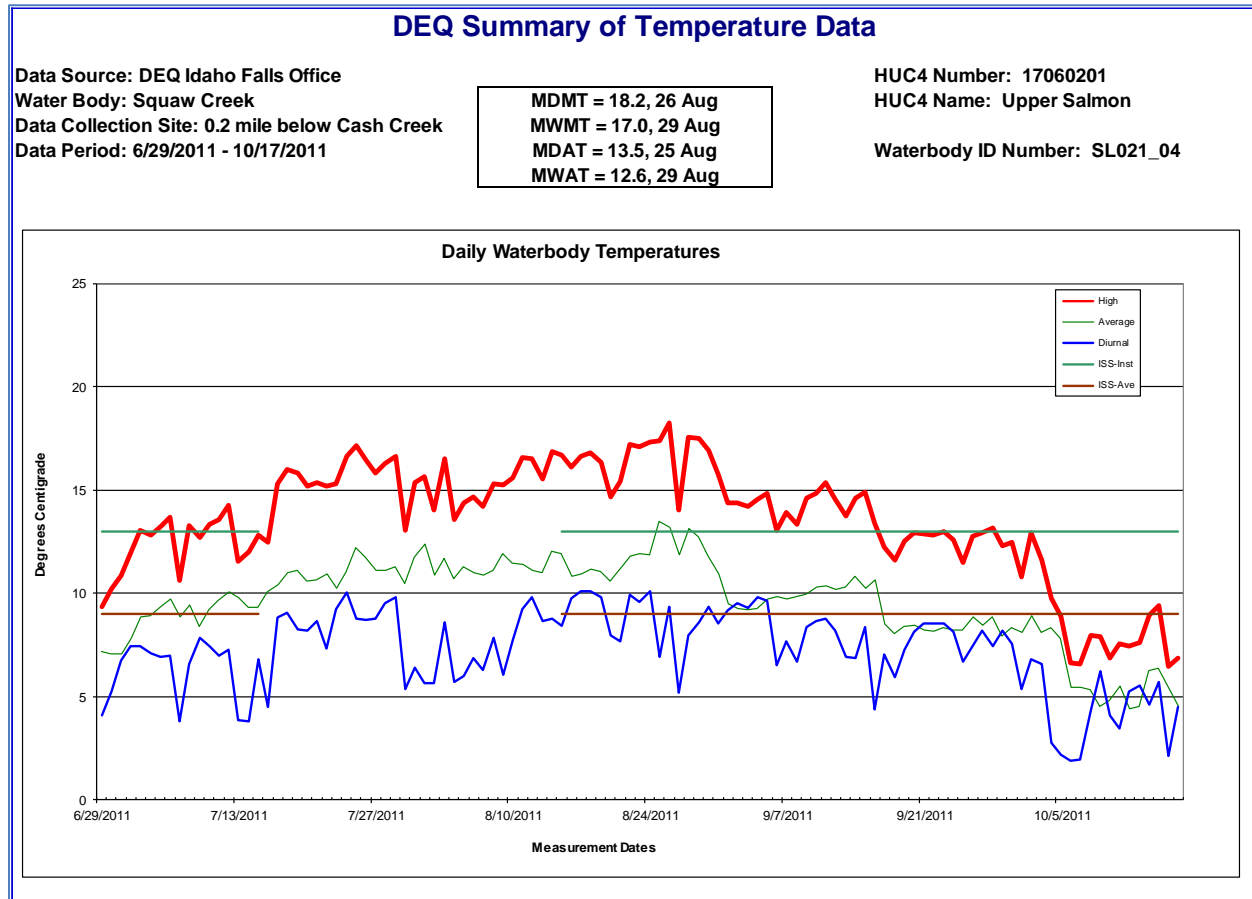
DEQ 2011 thermograph and exceedance table for Squaw Creek (AU ID17060201SL021_04)

Idaho Salmonid Spawning Criteria Exceedance Summary			
Criteria	Exceedance Counts		
	Nmbr	Prcnt	
13 °C Instantaneous Spring	7	41%	
9 °C Average Spring	9	53%	
Spring Days Eval'd w/in Dates	17	15-Apr	15-Jul
13 °C Instantaneous Fall	35	55%	
9 °C Average Fall	33	52%	
Fall Days Eval'd w/in Dates	64	15-Aug	31-Dec
13 °C Instantaneous Total *	42	52%	
9 °C Average Total *	42	52%	
Tot Days Eval'd w/in Both Dates *	81		
* If spring & fall dates overlap double counting may occur.

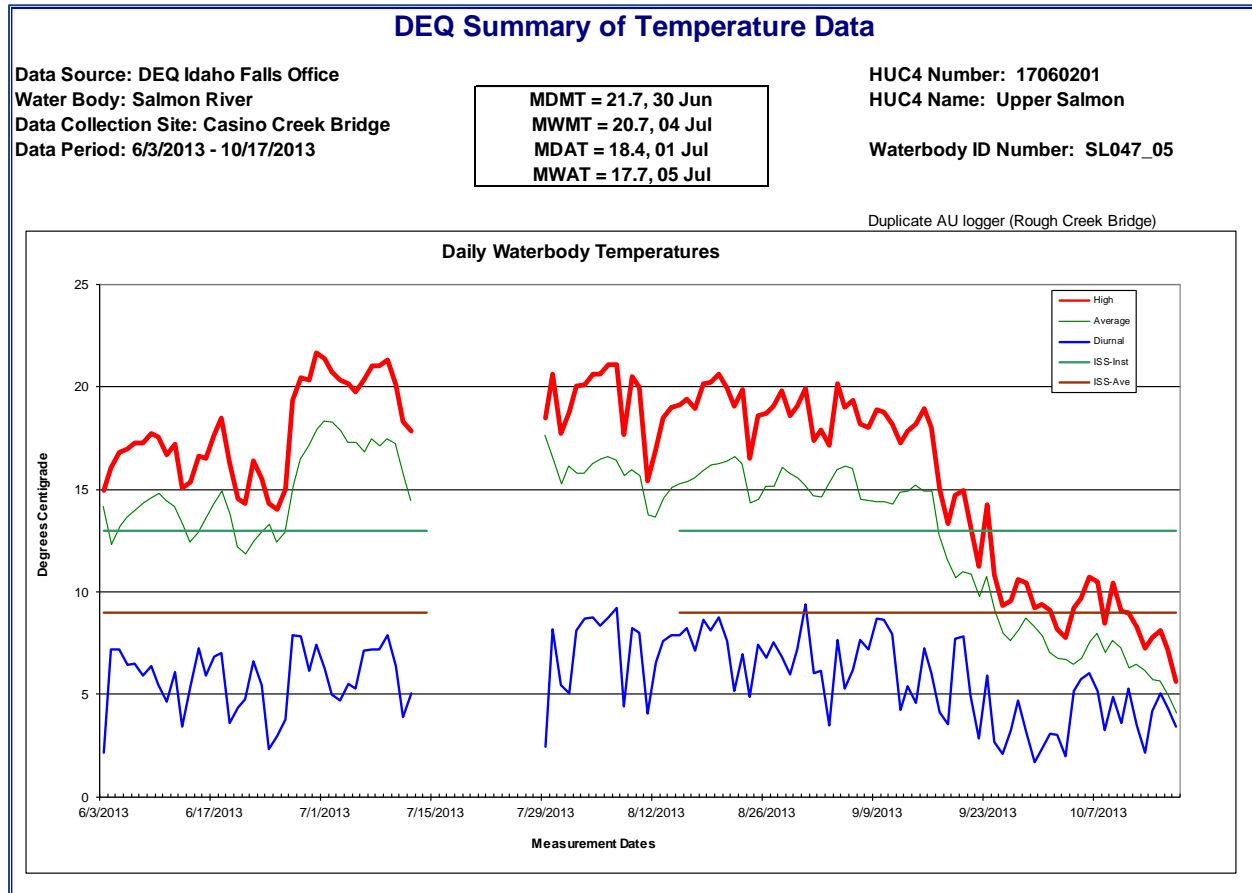
DEQ 2013 thermograph and exceedance table for the Salmon River at Casino Creek Bridge (AU ID17060201SL047_05)

Idaho Salmonid Spawning Criteria Exceedance Summary			
Criteria	Exceedance Counts		
	Nmbr	Prcnt	
13 °C Instantaneous Spring	40	100%	
9 °C Average Spring	40	100%	
Spring Days Eval'd w/in Dates	40	1-Apr	15-Jul
13 °C Instantaneous Fall	39	61%	
9 °C Average Fall	41	64%	
Fall Days Eval'd w/in Dates	64	15-Aug	31-Dec
13 °C Instantaneous Total *	79	76%	
9 °C Average Total *	81	78%	
Tot Days Eval'd w/in Both Dates *	104

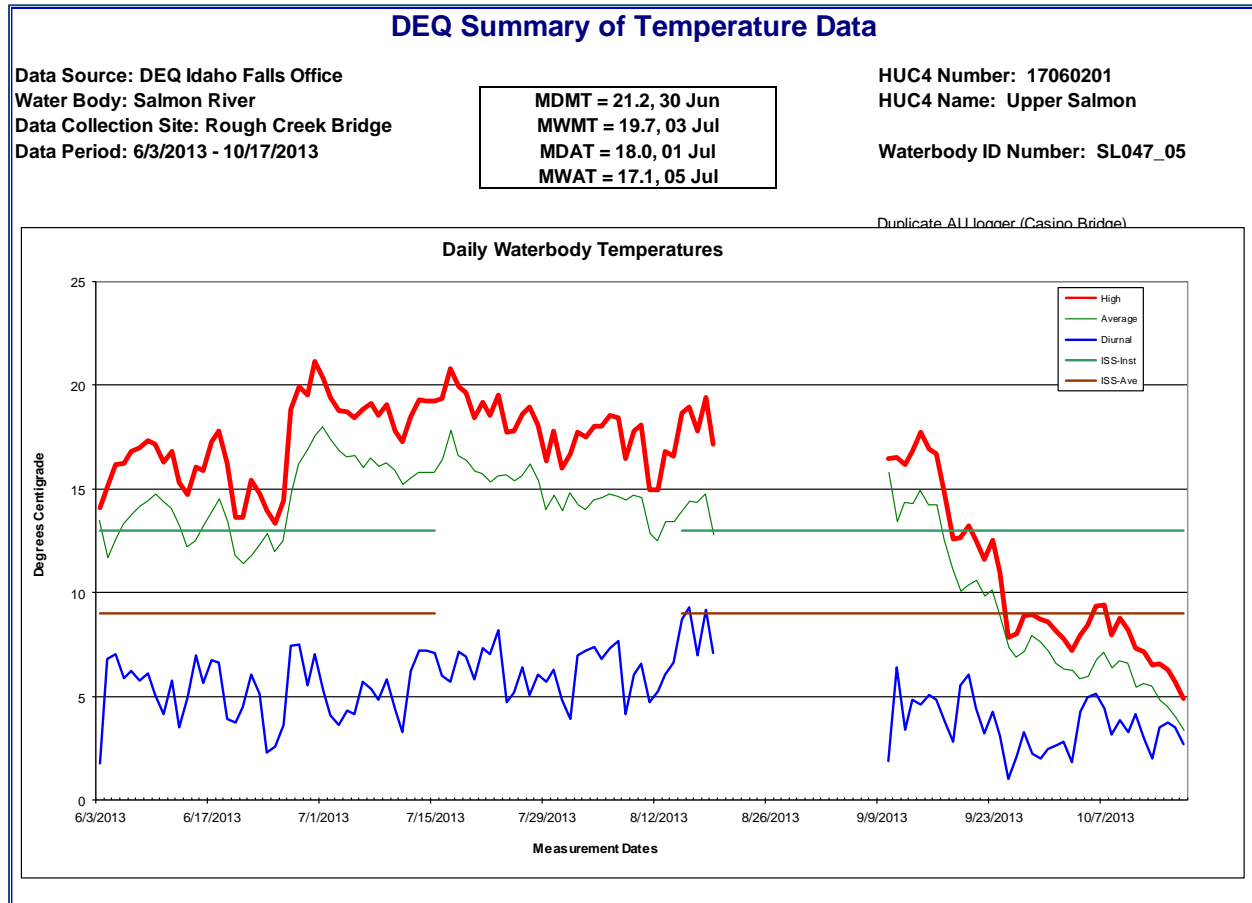
DEQ 2013 thermograph and exceedance table for the Salmon River at Rough Creek Bridge (AU ID17060201SL047_05) – Duplicate

Idaho Salmonid Spawning Criteria Exceedance Summary			
Criteria	Exceedance Counts		
	Nmbr	Prcnt	
13 °C Instantaneous Spring	43	100%	
9 °C Average Spring	43	100%	
Spring Days Eval'd w/in Dates	43	1-Apr	15-Jul
13 °C Instantaneous Fall	14	33%	
9 °C Average Fall	19	44%	
Fall Days Eval'd w/in Dates	43	15-Aug	31-Dec
13 °C Instantaneous Total *	57	66%	
9 °C Average Total *	62	72%	
Tot Days Eval'd w/in Both Dates *	86

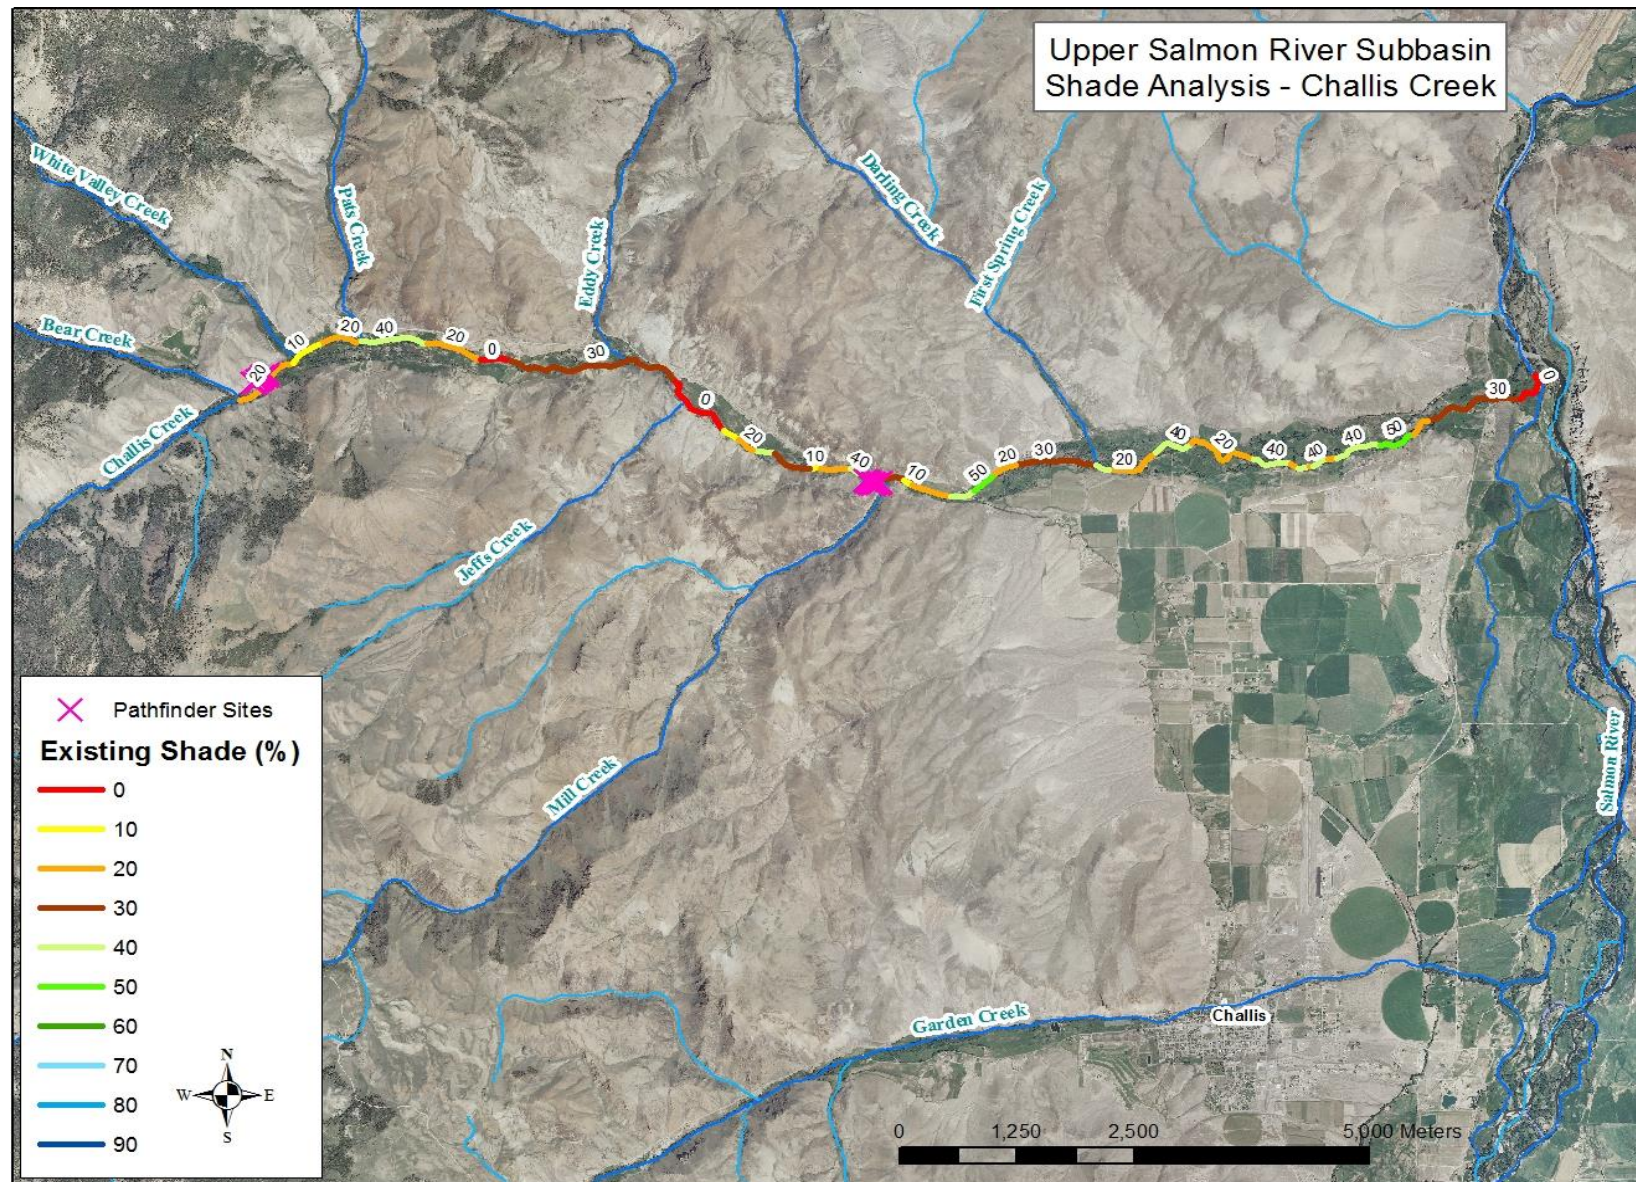
Figure H1. Existing shade estimated for Challis Creek by aerial photo interpretation.
